ROGERS DAM

MO 10370

PHASE I INSPECTION REPORT NATIONAL DAM SAFETY PROGRAM

DECEMBER 1978

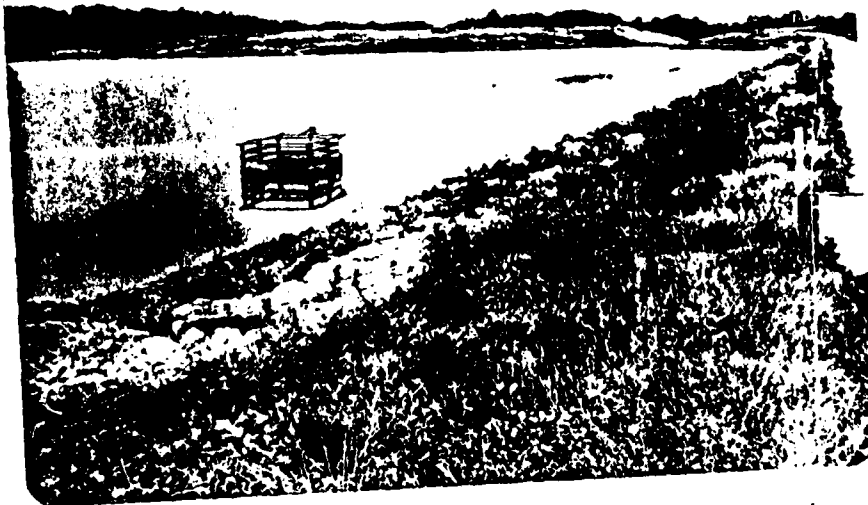
The horizontal alignment appeared as constructed. No surface cracking or unusual movement was obvious. The riprap on the embankment appeared to be in good condition. Some sloughing and shore erosion was noted along the shoreline (natural material) between the north end of the dam and the emergency spillway. This section was not riprapped.

Upstream Slope of Dam - Looking North

The shoreline between the north end of the dam and the emergency spillway may need riprap in the future to prevent further sloughing. The drainage blanket outlet pipe should be located, repaired if necessary, and marked to prevent future damage by maintenance equipment. Free drainage of the drainage blanket is important to avoid possible piping or stability problems in the future.

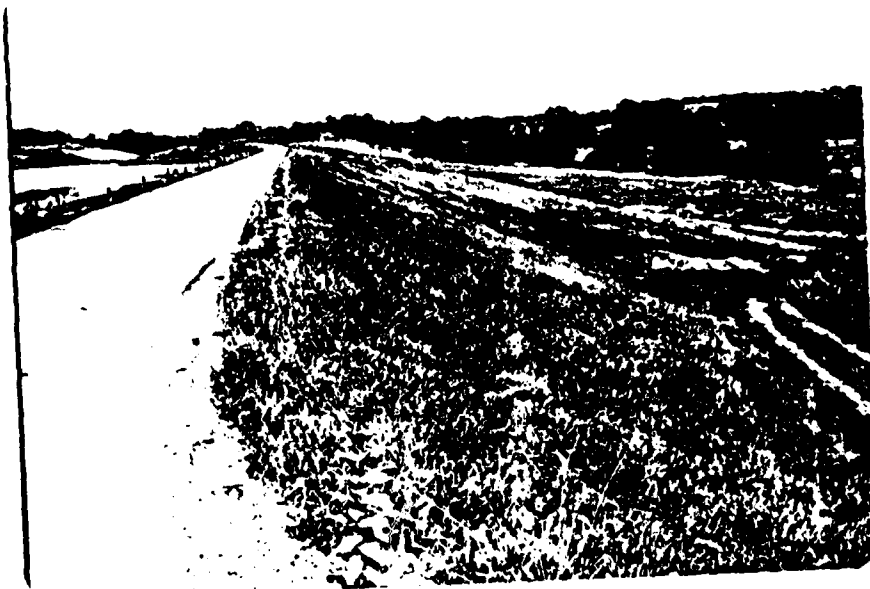
No sloughing of the embankment or seepage through or under the embankment was evident. The drain pipe for the drainage blanket could not be found and may have been damaged and covered by past mowing and maintenance equipment. The floodplain below the dam was green and moist. However, a rainstorm in the area about one hour before our site visit may account for the moist condition.

Downstream Slope of Dam - Looking North

- (5) The drainage blanket outlet pipe should be located, repaired and marked to prevent future damage by maintenance equipment.
- (6) Check the downstream slope periodically for seepage and stability problems (especially in the area of the raw water pipe under the dam). If wet areas or seepage flows are observed, or if sloughing is noted, then the dam should be inspected immediately and the situation evaluated by an engineer experienced in design and construction of dams. The area around the raw water pipe egress should be inspected periodically and if significant seepage and the beginning of erosion around the pipe are found, the situation should be evaluated by a geotechnical engineer.

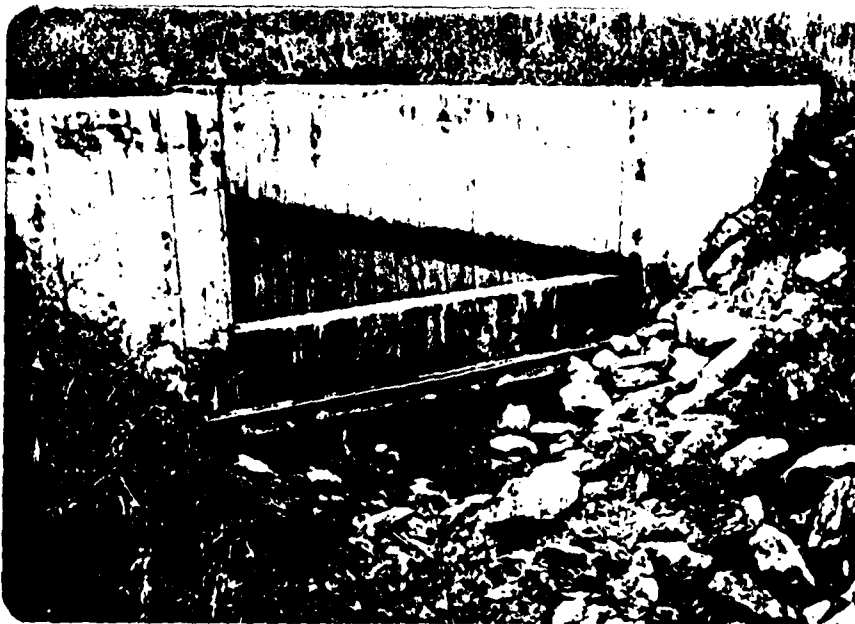
The riser structure could not be directly inspected since it is in the water. Visual inspection from the dam did not indicate any apparent problems. The outlet pipe and stilling basin structure are in good condition. Considerable erosion has taken place at the end of the stilling basin structure. Riprap has been carried away, and some of it is piled in the center of the outlet channel (see picture - Sheet 3 of Appendix D). The outlet channel is in fairly good condition downstream of this area.

Primary Spillway Outlet - Note Erosion

The erosion which was noted on the slope below the downstream berm and especially on the south abutment and at the end of the sill block at the primary spillway outlet should be corrected and maintained. The south abutment erosional area should be regraded, and an effort should be made to minimize future erosion. The erosional area at the end of the sill block should be corrected immediately and maintained.

- (2) The erosion which was noted at the end of the sill block at the primary spillway outlet should be corrected immediately and maintained.
- (3) The erosion which was noted on the slope below the downstream berm and on the south abutment should also be corrected in the near future and maintained. Possibly, future erosion can be minimized with the use of riprap or ditch checks.

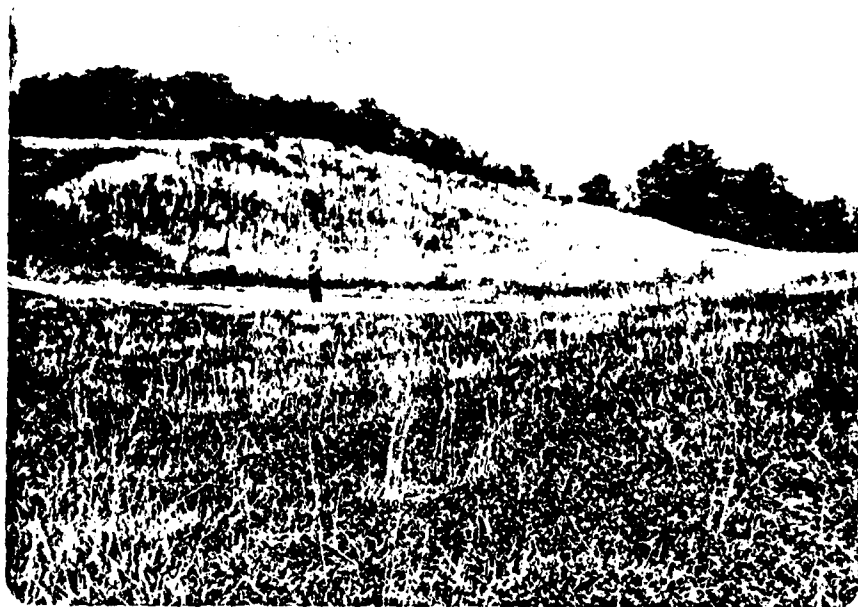
The emergency spillway is in good condition. It measures 100 ft in width at the concrete sill control section with 3h:1v side slopes. Information from a local source indicates that it may have been used once. The emergency spillway is not lined but is partially cut in rock. Some erosional damage would be incurred during full flow, but the damage would not be expected to be catastrophic and would be repairable.

Emergency Spillway - Looking Upstream
